MARINE INVESTIGATION REPORT

M00W0044

CAPSIZING

**THE FISHING VESSEL “LORI CATHLYNN”
SEAFORTH CHANNEL
WAGLISLA (BELLA BELLA), BRITISH COLUMBIA
28 MARCH 2000**

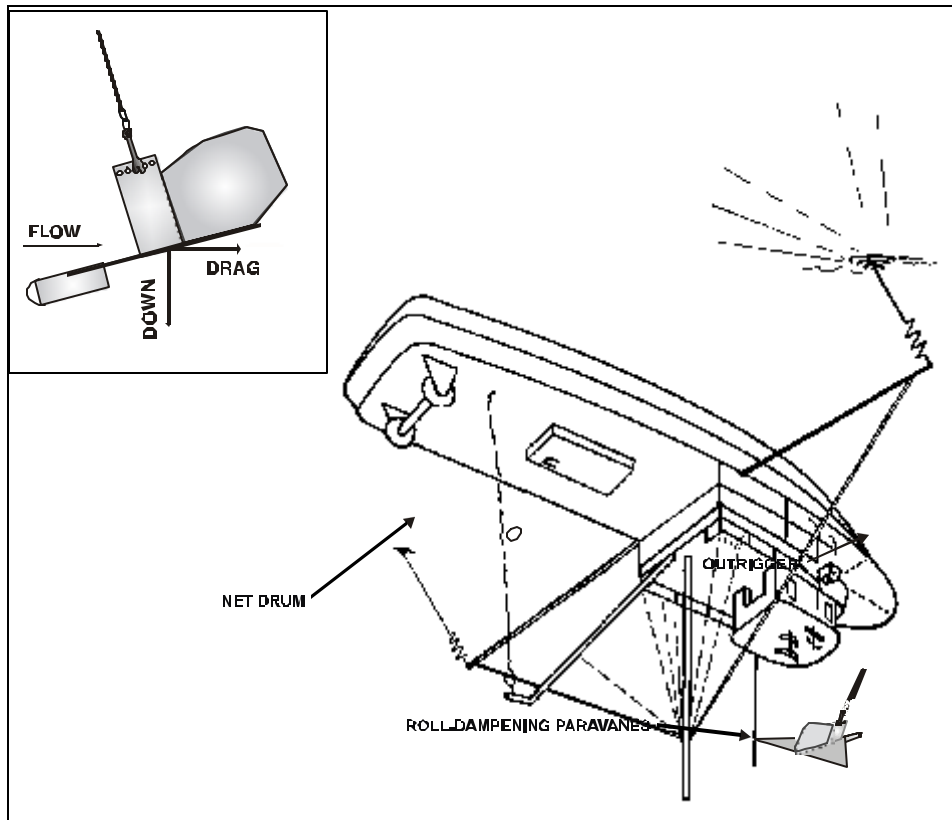
Figure 2 - Typical arrangement of roll-dampening paravanes, and the forces produced by a paravane

Roll-dampening paravanes were fitted to the "LORI CATHLYNN" on port and starboard outriggers attached to the bulwarks. The paravanes were in use at the time of the occurrence. Post-occurrence inspection of the vessel showed that the cable to the starboard paravane stabilizer was ruptured at the eyelet's extremity. The paravane could not be found on the vessel. It could not be ascertained if it was lost at the time of the occurrence or while towing the upturned vessel the following day.

The use of roll-dampening paravanes is not without risk. The safe functioning of the submerged delta-shape is largely dependent on the towing speed and on their complementary operation—to port and starboard—such that the righting moment caused by the downward force generated on one side is synchronized with the upward roll of the vessel on that same side. If the port and starboard synchronization is disturbed or lost, an athwartships moment can be applied to the vessel when she is rolling toward the paravane generating the most downward force, and the vessel's roll may actually be increased on that side. The synchronous and complementary operation would be significantly disturbed if one paravane became fouled on an obstruction. In addition, the skipper's action of steering to port when the vessel was heeling to starboard would have unfortunately affected the heeling to starboard.

3. The roll-dampening paravanes were being used at the time of the occurrence.
4. A combination of the dynamic heeling effect of the paravane on the starboard side, free surface effects of the liquids and a load of herring spawn on deck reduced the vessel's righting ability, causing it to roll to starboard and to heel rapidly.

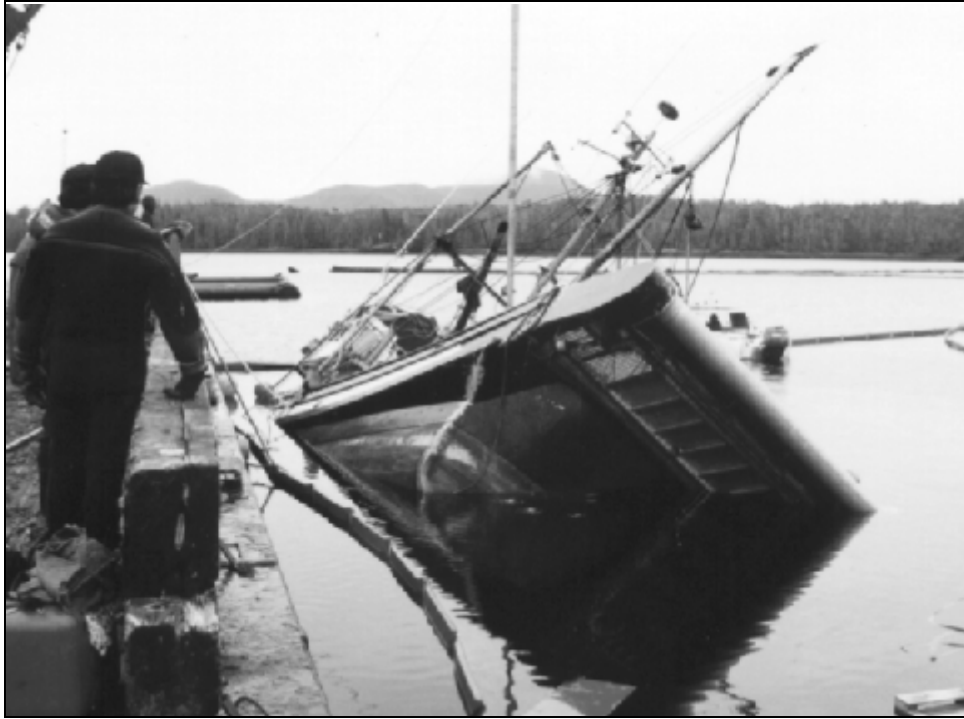
Photo 1 - Salvage of the "LORI CATHLYNN"

The "LORI CATHLYNN" was taken in tow to Shearwater, B.C., for salvage, inspection and repairs (see Appendix C, Photos 1 and 2).

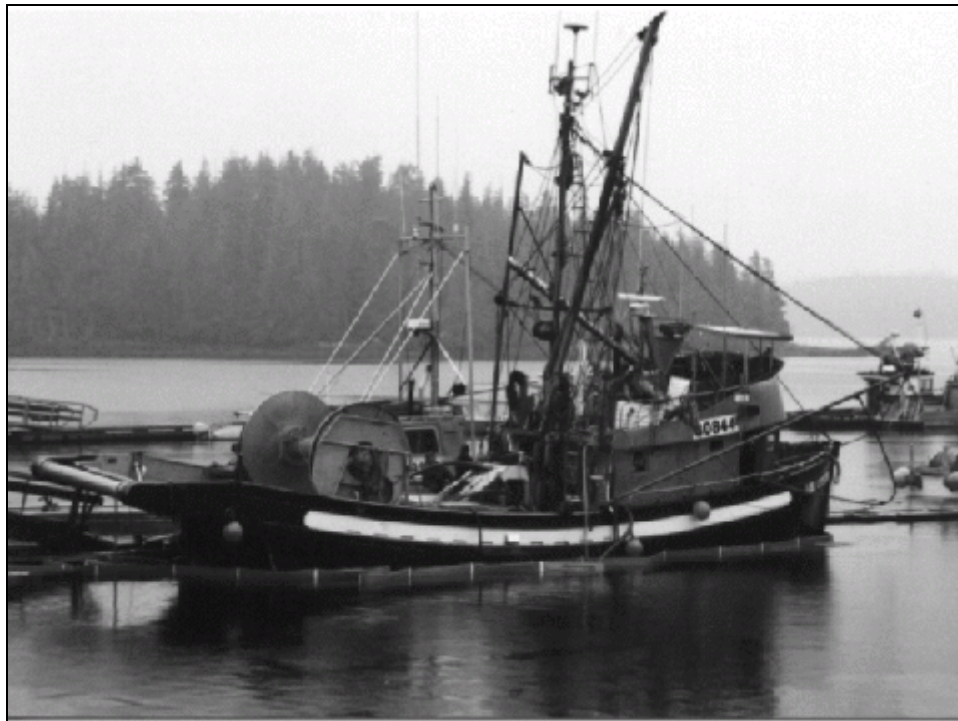
Photo 2 - The "LORI CATHLYNN" after recovery

The flush deck scuttles of the lazarette and of the port fish hold were missing and the main hatch of the fish holds was not in place when the vessel was recovered. The deck scuttles were lost, indicating that they had not been secured. Although required by regulations, the deck scuttle cover was neither hinged nor secured by a chain to the vessel's structure. The sudden heeling and the action of sea water swamping the vessel's deck would have dislodged them from the hatch coamings, allowing the ingress of water. The resultant downflooding of the lazarette and of the fish hold would have increased the heel and hastened the capsizing.

In response, TCMS indicated that they have re-inspected the vessel and carried out a roll test. The vessel is presently back in operation with the following conditions limiting its operation:

- the forward fish hold centerline bulkhead's extension to be in place at all times except when the net is stored in the hold, and
- free surface effects to be reduced to a minimum (hold full /empty) when carrying tote boxes on deck (herring spawn on kelp), and a minimum freeboard of 0.46 metre (18 inches) to be maintained in the fully loaded condition.
